OMAE2017-XXXXX

**DEVELOPMENT AND TESTING OF A FRICTION-BASED POST-INSTALLABLE
SENSOR FOR SUBSEA FIBER-OPTIC MONITORING SYSTEMS**

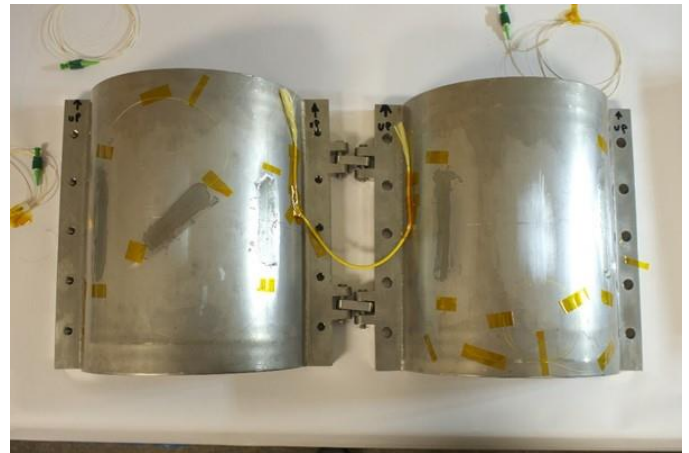
Figure 5. 8-INCH FRICTION CLAMP PROTOTYPE

In order to evaluate the Mark I design, sub-scale prototypes were built and tested. One friction clamp prototype with a 4-inch diameter and two friction clamp prototypes with an 8-inch diameter were fabricated. A photograph of an 8" friction clamp prototype is shown in Figure 5. The friction clamp prototype clamshells were fabricated by NASA-JSC, and the fiber optic sensors were installed onto the clamshells by ATI. Each friction clamp prototype has 4 axial fiber optic sensors and 1 diagonal fiber optic sensor. The four axial sensors are positioned 90 degrees apart along the circumference of the clamshell. The axial sensors measure the tensile and compressive strains, and the diagonal sensor measures the bias strain.

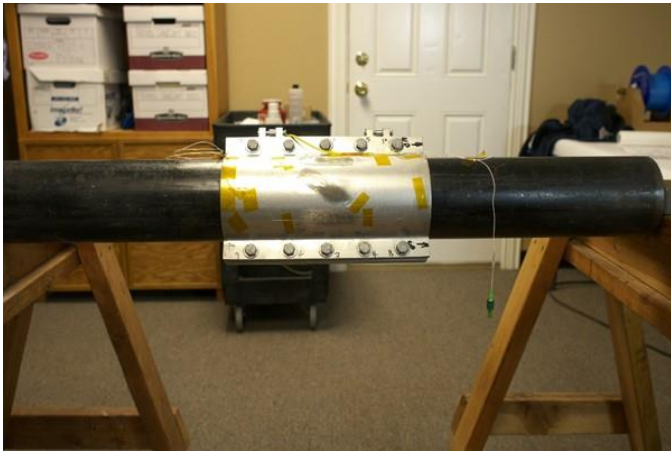
Figure 6. TEST ASSEMBLY WITH 4" FRICTION CLAMP PROTOTYPE

One 4" friction clamp and one 8" friction clamp prototype were used for tension/compression testing. The other 8" friction clamp prototype was used for 4-point bending tests. The 4" friction clamp bolts were torqued to 5 ft.-lbf and the 8" friction clamps bolts were torqued to 10 ft.-lbf. Additional torque was applied during tension/compression testing to assess the effect of bolt torque on the clamp's grip strength and the fiber optic sensor strain measurements. After the clamp installation, conventional resistance strain gauges were also installed on the test pipes to complete the test assemblies. Each test assembly was subjected to various loading scenarios, and the strain measurements from the fiber optic sensors and the resistance strain gauges were recorded and analyzed. The accuracy and resolution of the prototype's fiber optic sensor system were evaluated by comparing the measurements to the data from the resistance strain gauges. A photograph of a friction clamp test assembly is shown in Figure 6.

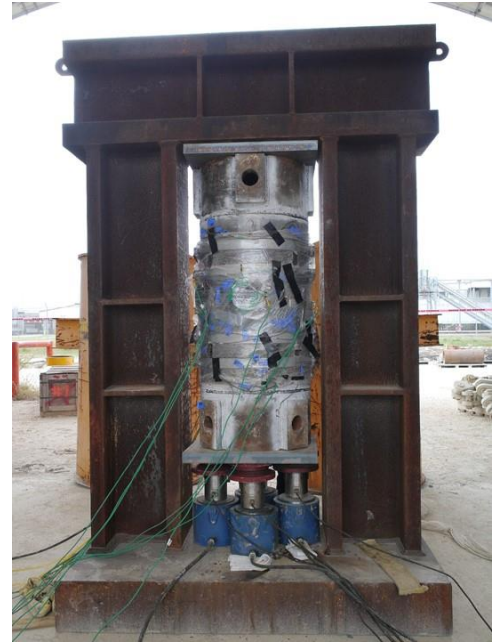
Figure 11. MARK II PROTOTYPE COMPRESSION TEST SETUP

A full size Mark II prototype was built by ATI and tested. A photograph of a compression test setup is shown in Figure 11. At the time of this writing, the data from the Mark II prototype testing had not been fully analyzed yet. However, preliminary results indicated that the fiber-optic sensor measurements were tracking well with the reference strain gauge measurements. There are also less deviation between the tension and compression measurements, which suggests that the new design was maintaining a high level of coupling during the tension tests. Preliminary strain data from the Mark II prototype tension/compression tests are shown in Figure 12.
